TECHNICAL REPORT

THE IMMEDIATE TRAFFICKING OF CEMENT BOUND MATERIALS

The immediate trafficking of cement bound materials

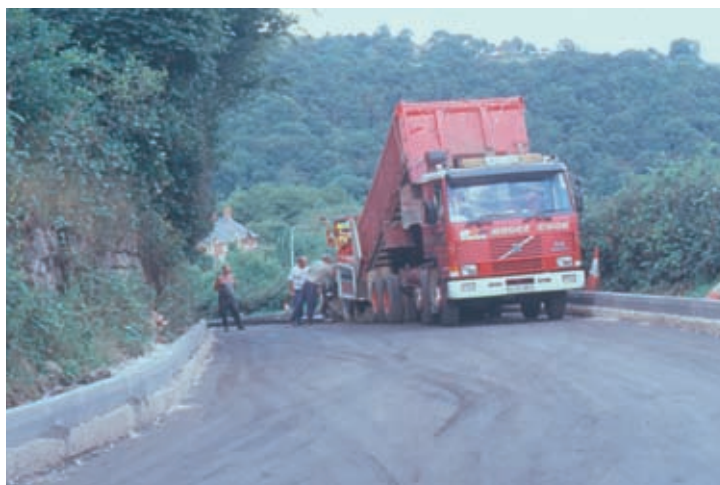
GFA for the A52 reconstruction work, 1997: Freshly laid and compacted GFA was subject to immediate trafficking by fully loaded 8-wheeler lorries bringing in fresh GFA and the bituminous binder course (Figure 1). Except for minor surface disturbance under turning traffic, no distress in the form of measurable rutting or cracking was apparent. Subsequent coring and falling weight deflectograph work has illustrated that the long-term performance was not jeopardized in any way due to the immediate trafficking [2]

Figure 1: A52 Reconstruction, Staffordshire, 1997 – trafficking and overlaying fresh GFA subbase

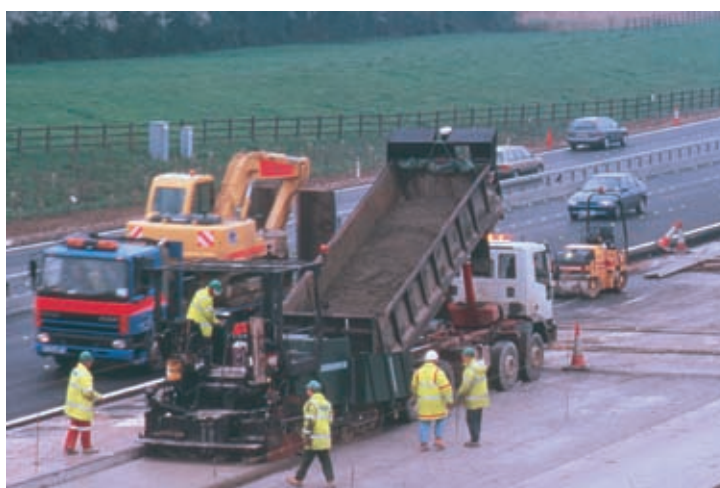
FSBM for the M25 reconstruction work, 2001: Similarly to the A52, such was the site access and programme that freshly laid and compacted FSBM was usually overlain immediately with CBM subbase (Figure 2). Again no measurable rutting or cracking was apparent with no evidence of any effect on performance.

Figure 2: M25 Reconstruction, Clacket Lane, 2001 – fresh FSBM being overlaid by CBM

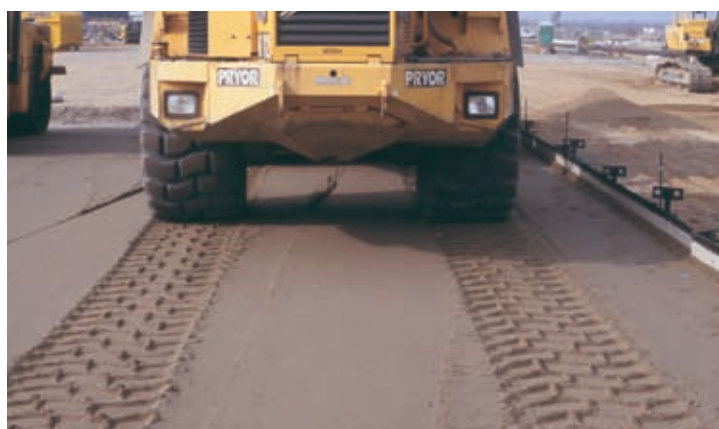
Figure 3: Mixture M1 showing significant surface disturbance under trafficking

Mixture ref	Observation	Rating
M1	Significant surface disturbance	Poor (see Figure 3)
M2	Minimal rutting and surface disturbance	Excellent (see Figure 4)
M3	Minimal rutting and surface disturbance but roller shear cracks due to excess fines	Satisfactory
M4	Not assessed	Not assessed
M5	No significant rutting but surface easily disturbed and sheared through lack of cohesion	Poor (see Figure 5)
M6	Taken from TRL 408, i.e. rutting up to 8 mm, assessed as not detrimental to long term performance in TRL 408	Satisfactory
M7	No marking or visible deformation	Excellent ((see Figure 6)
M8	Assumed similar to M7	Not observed
M9	No marking or visible deformation, although assessment was based on observation of performance just under wheels of roller, but could have been susceptible to more deformation with heavier wheeled traffic	Satisfactory
M10	Some minor deformation under first passes of loaded lorry tyres but thereafter lorry acted like a pneumatic-tyred roller and produced a tightly sealed rut-resistant surface	Excellent (see Figure 7)

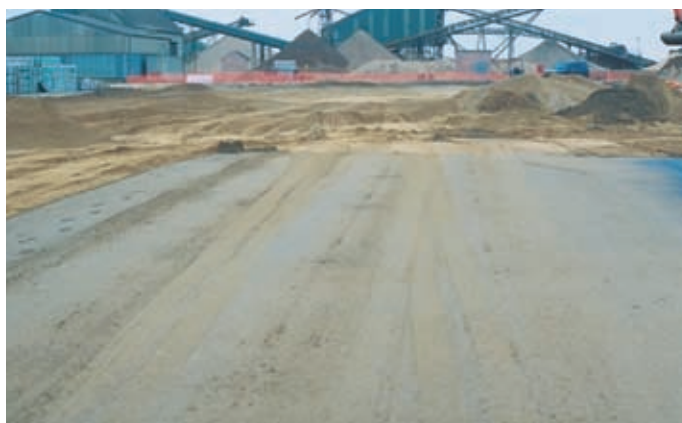
Figure 4: Mixture M2 after trafficking by loaded lorry

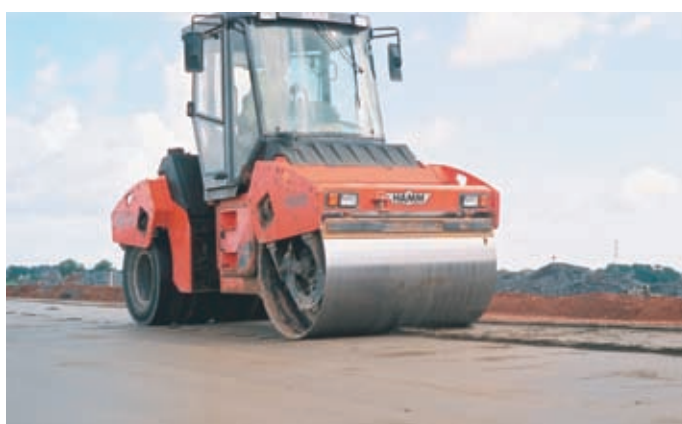
Figure 5: Mixture M5 showing shearing under roller

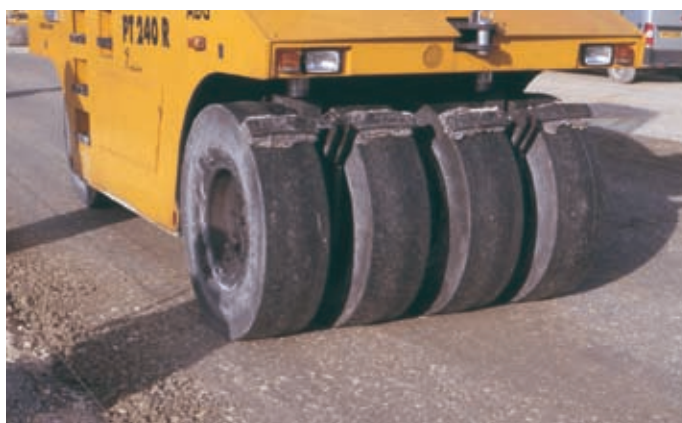
Figure 6: Mixture M7 under pneumatic-tyred roller

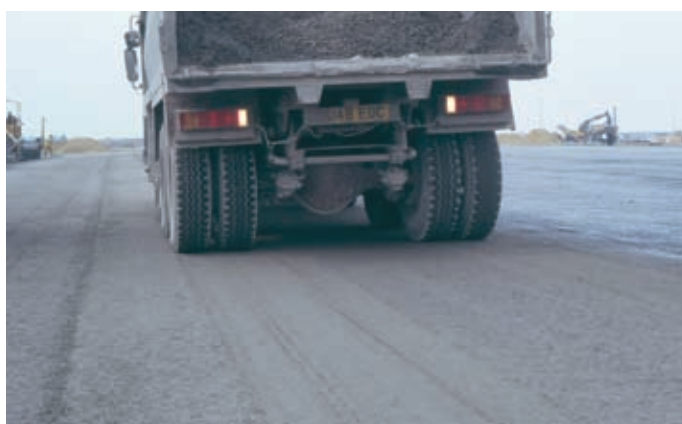
Figure 7: Mixture M10 showing improvement under tyred traffic after vibrating roller compaction
