TECHNICAL REPORT

THE IMMEDIATE TRAFFICKING OF CEMENT BOUND MATERIALS

This is the report of collaborative project between the Highways Agency and Britpave.

The immediate trafficking of cement bound materials

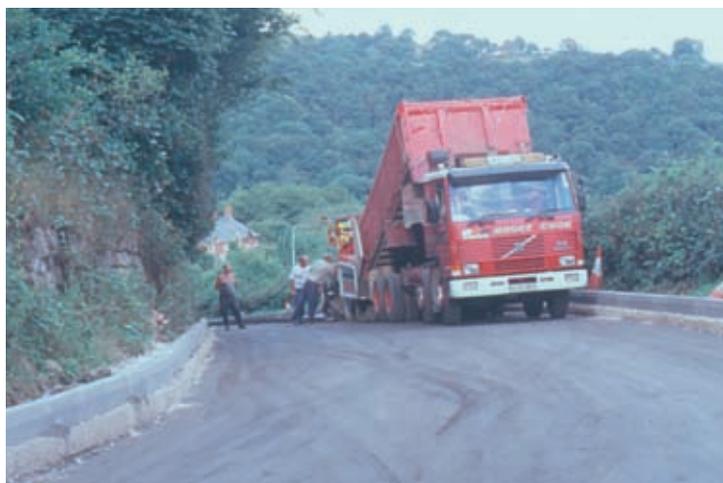
GFA for the A52 reconstruction work, 1997: Freshly laid and compacted GFA was subject to immediate trafficking by fully loaded 8-wheeler lorries bringing in fresh GFA and the bituminous binder course (Figure 1). Except for minor surface disturbance under turning traffic, no distress in the form of measurable rutting or cracking was apparent. Subsequent coring and falling weight deflectograph work has illustrated that the long-term performance was not jeopardized in any way due to the immediate trafficking [2]

Figure 1: A52 Reconstruction, Staffordshire, 1997 – trafficking and overlaying fresh GFA subbase

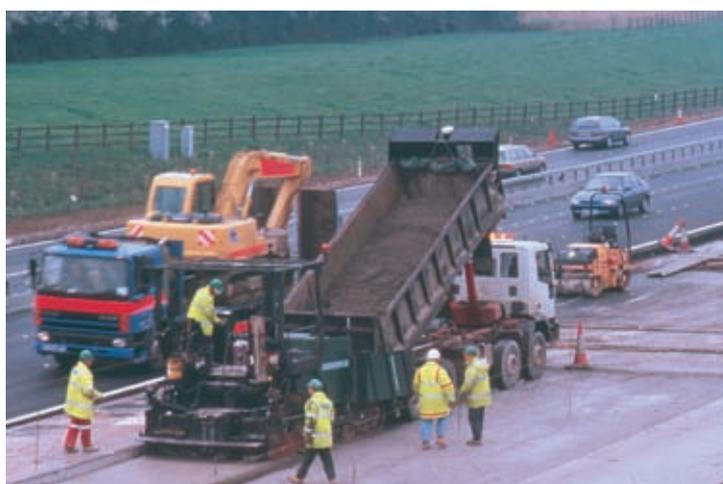
FSBM for the M25 reconstruction work, 2001: Similarly to the A52, such was the site access and programme that freshly laid and compacted FSBM was usually overlain immediately with CBM subbase (Figure 2). Again no measurable rutting or cracking was apparent with no evidence of any effect on performance.

Figure 2: M25 Reconstruction, Clacket Lane, 2001 – fresh FSBM being overlaid by CBM

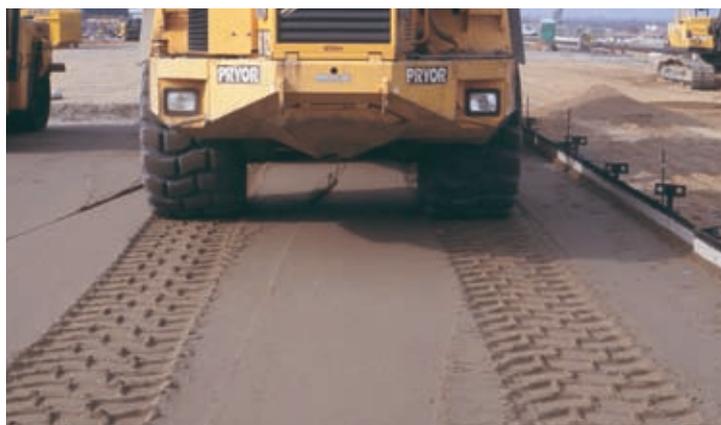
Figure 3: Mixture M1 showing significant surface disturbance under trafficking

Mixture ref	Observation	Rating
M1	Significant surface disturbance	Poor (see Figure 3)
M2	Minimal rutting and surface disturbance	Excellent (see Figure 4)
M3	Minimal rutting and surface disturbance but roller shear cracks due to excess fines	Satisfactory
M4	Not assessed	Not assessed
M5	No significant rutting but surface easily disturbed and sheared through lack of cohesion	Poor (see Figure 5)
M6	Taken from TRL 408, i.e. rutting up to 8 mm, assessed as not detrimental to long term performance in TRL 408	Satisfactory
M7	No marking or visible deformation	Excellent ((see Figure 6)
M8	Assumed similar to M7	Not observed
M9	No marking or visible deformation, although assessment was based on observation of performance just under wheels of roller, but could have been susceptible to more deformation with heavier wheeled traffic	Satisfactory
M10	Some minor deformation under first passes of loaded lorry tyres but thereafter lorry acted like a pneumatic-tyred roller and produced a tightly sealed rut-resistant surface	Excellent (see Figure 7)

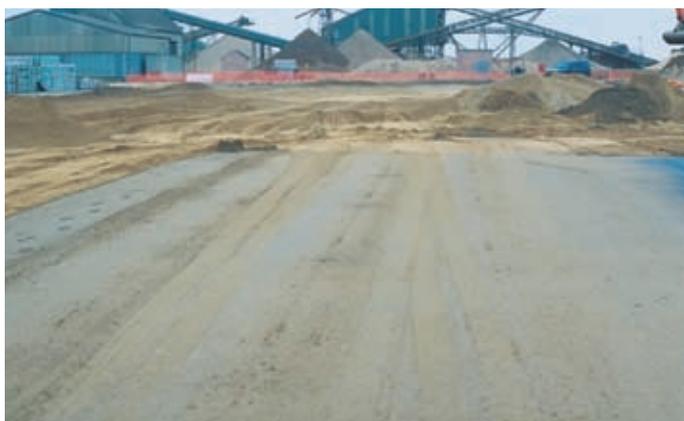
Figure 5: Mixture M5 showing shearing under roller

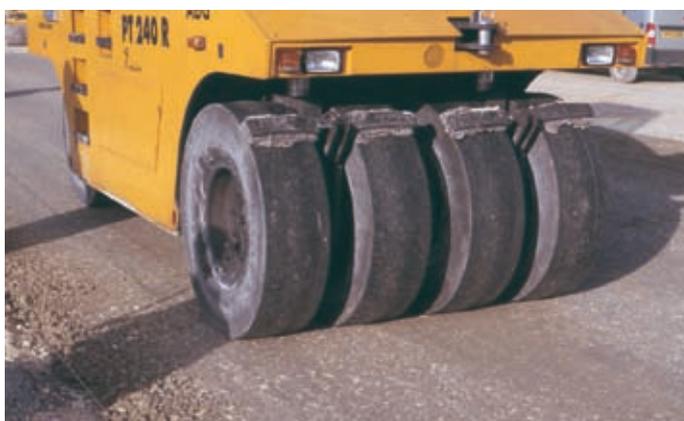
Figure 7: Mixture M10 showing improvement under tyred traffic after vibrating roller compaction
